Sunscreen damage on coated steel products

RSC TECHNICAL BULLETIN

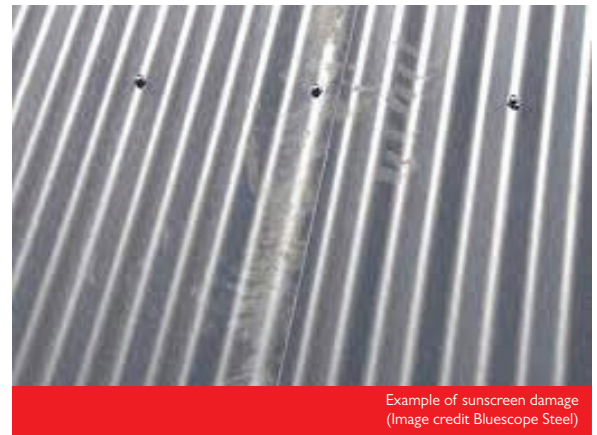
When sunscreens containing titanium dioxide (TiO₂) and zinc oxide (ZnO) are applied to Colorbond®, it can cause a fast acting chemical reaction that degrades the quality of the material, causing stains and loss of its gloss finish.

Example of sunscreen damage
(Image credit Bluescope Steel)

The best option to avoid damaging the Colorbond® is prevention, as once it has made contact with the material, it cannot be cleaned off, and in fact, attempting to clean it may cause further damage.

Check the active ingredients in your sunscreen before you buy it. Avoid anything with titanium dioxide (TiO₂) and zinc oxide (ZnO).

Use clean gloves when handling the Colorbond® and of course, wear correct PPE at all times to protect yourself from UV rays.
